Standard Checklist

Name of Riparian-Wetland Area: Hitchcock Creek

Date: May 26, 2004 Segment/Reach ID: Reach 8, After Bridge 513 PFC 308

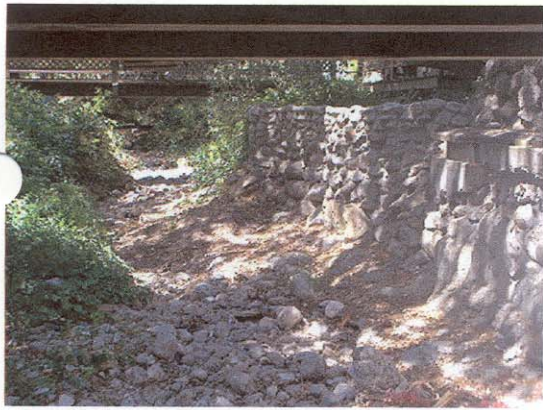
There are three large eroding and headcut hillsides that may be contributing to the large sediment piles found throughout the reach and on either side of Bridge 513 (See Pictures 2 and 4). The creek is also undercutting these three hillsides and exposing roots.

#5, 17 The eroding hillsides are contributing sediment and an excess of sediment has been found throughout the creek.
