Standard Checklist

Name of Riparian-Wetland Area: Finch Creek

Date: July 27, 2004 Segment/Reach ID: Reach 3 PFC 712

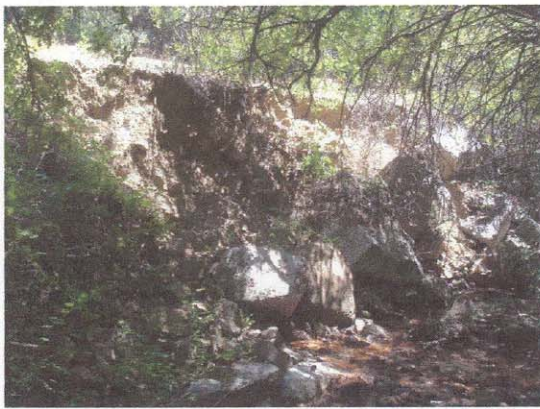
There are a few undercut banks and one landslide off of the county road above, where an attempt at stabilizing with boulders has failed (See Picture 1).
