Standard Checklist

Name of Riparian-Wetland Area: Tularcitos Creek

Date: August 10, 2004 Segment/Reach ID: Reach 2 PFC 904

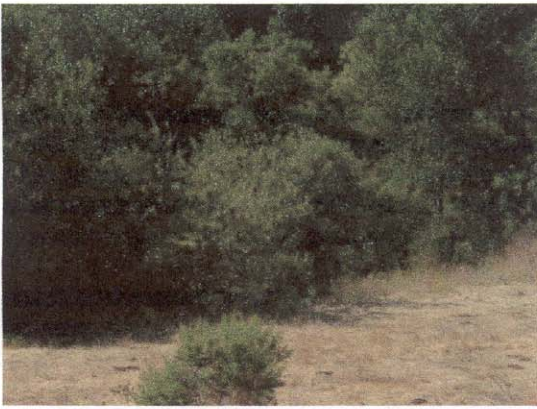
This reach was assessed from the sides of Carmel Valley Road. This reach started at the driveway of 33900 Carmel Valley Road. There are three medium sized culverts on each side of the concrete ford of this address. This reach of the creek runs through a cow pasture, and residential land.
