## EXHIBIT 12-A

### Carmel River Bank Stabilization at Rancho San Carlos Road Project Description and Work Plan

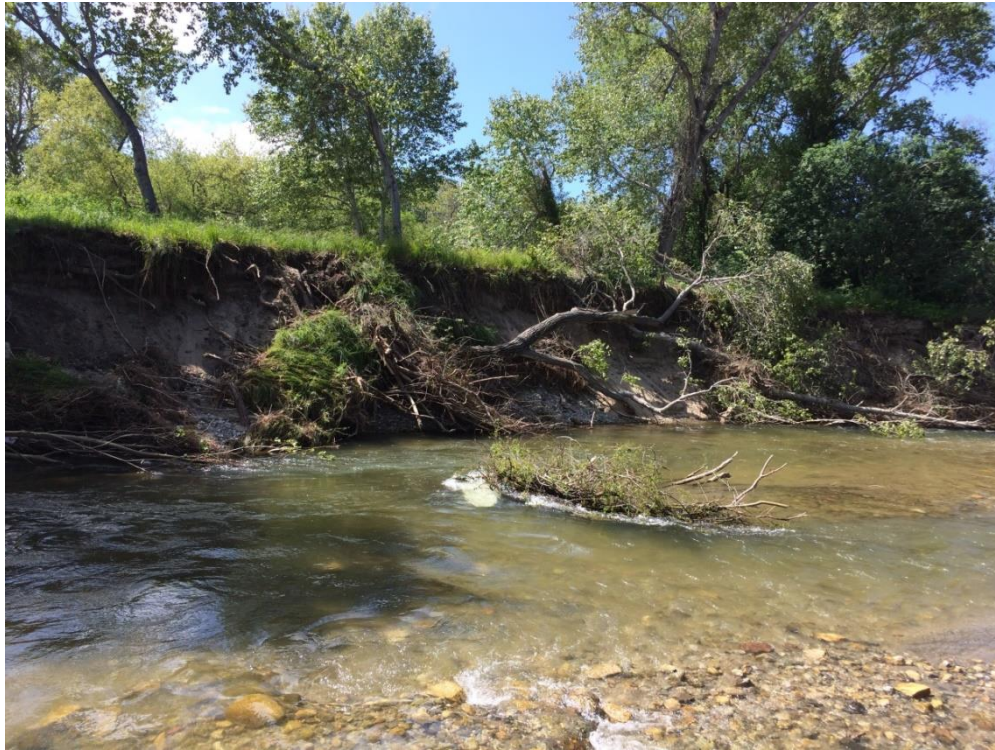
Figure 2. Left streambank after winter of 2017 erosion event (note lack of protective vegetation)

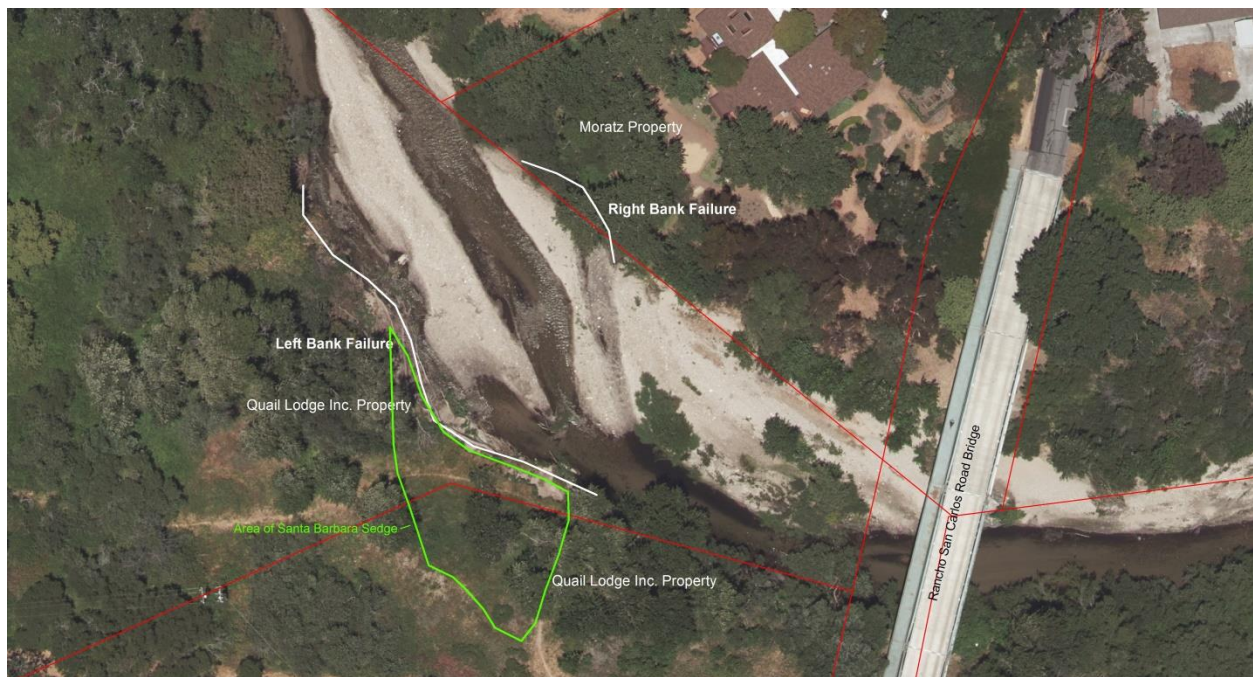
Figure 3. Aerial image showing locations of erosion just downstream of Rancho San Carlos Road Bridge

The proposed Carmel River Bank Stabilization at Rancho San Carlos Road Project (RSC Project) is located at River Mile 3.8 (measured from the Pacific Ocean) just downstream of the Rancho San Carlos Road Bridge (**Figure 1**). The project area contains two eroding stream banks almost opposite from each other. Concern for the stability of the right bank (Moratz Property) started in 2011 and interim measures such as jute netting, willow planting, and irrigation were carried out to try and stabilize the bank. Then in February of 2017, during a high flow event (9,570 cubic feet per second at the U.S.G.S Near Carmel gage) the left bank on Quail Lodge Property experienced significant erosion and approximately 10 to 15 feet of bank eroded along 300 lineal feet (**Figure 2**). During the high flows, numerous large cottonwood trees toppled out of the river bank and culturally significant Santa Barbara Sedge beds were lost. Currently the left bank is very vulnerable to erosion from high flows because it has lost its protective vegetative cover and is on the outside of a meander bend in an area that can erode during high flows. Because these vulnerable streambanks are so close together, work on one bank can impact the other. Therefore, a comprehensive project addressing both banks is being proposed (**Figure 3**).

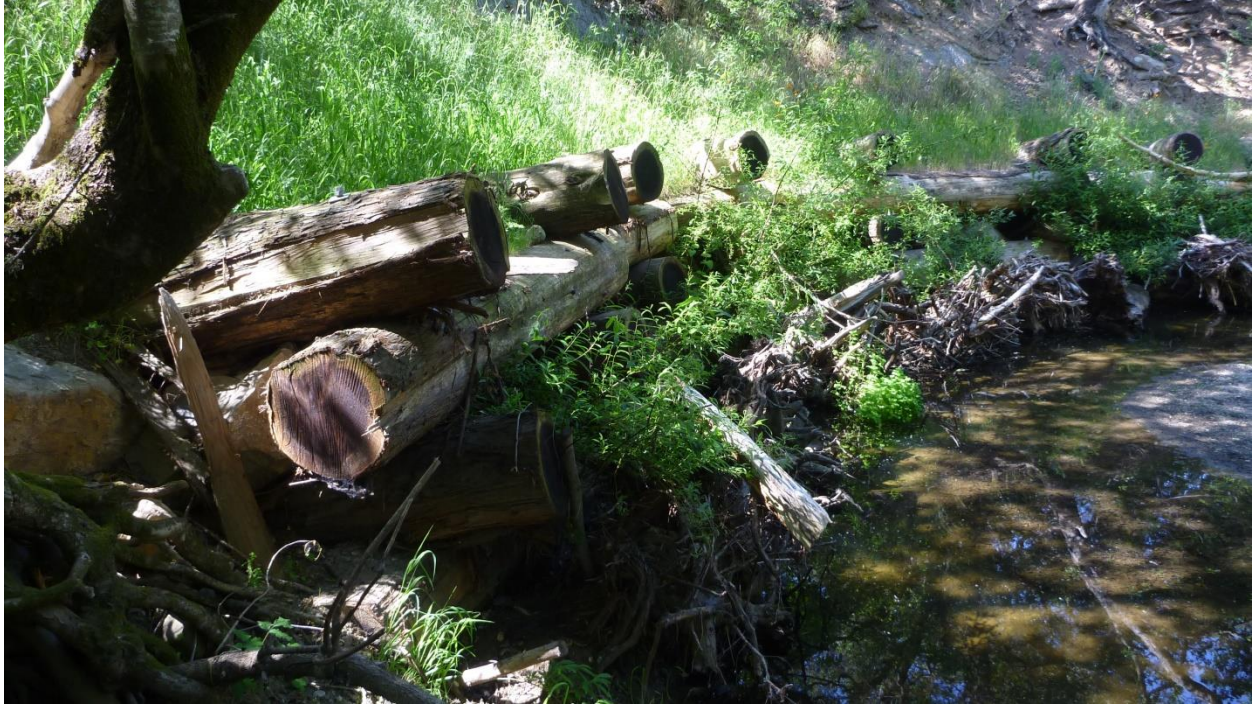
Figure 6. Example of completed log cribwall

Once vegetation starts to mature at both the cribwall and the right bank structure many of the elements of the design will start to blend in with the surrounding environment. A picture of a previously constructed cribwall with vegetation was provided by Balance Hydrologics (**Figure 6**).
