X. RIPARIAN HABITAT MITIGATION MEASURES

A. Conservation and Water Distribution Management to Retain Water in the Carmel River

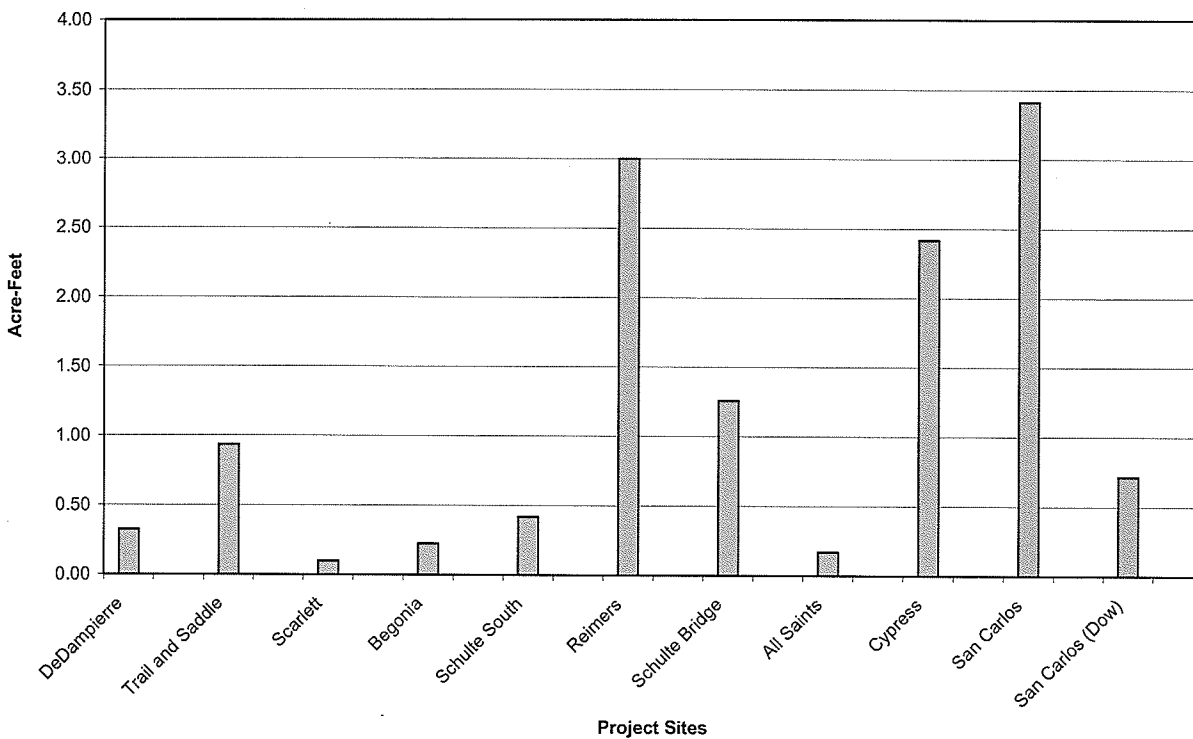
Figure X-1

July 2007 - June 2008 Irrigation Totals

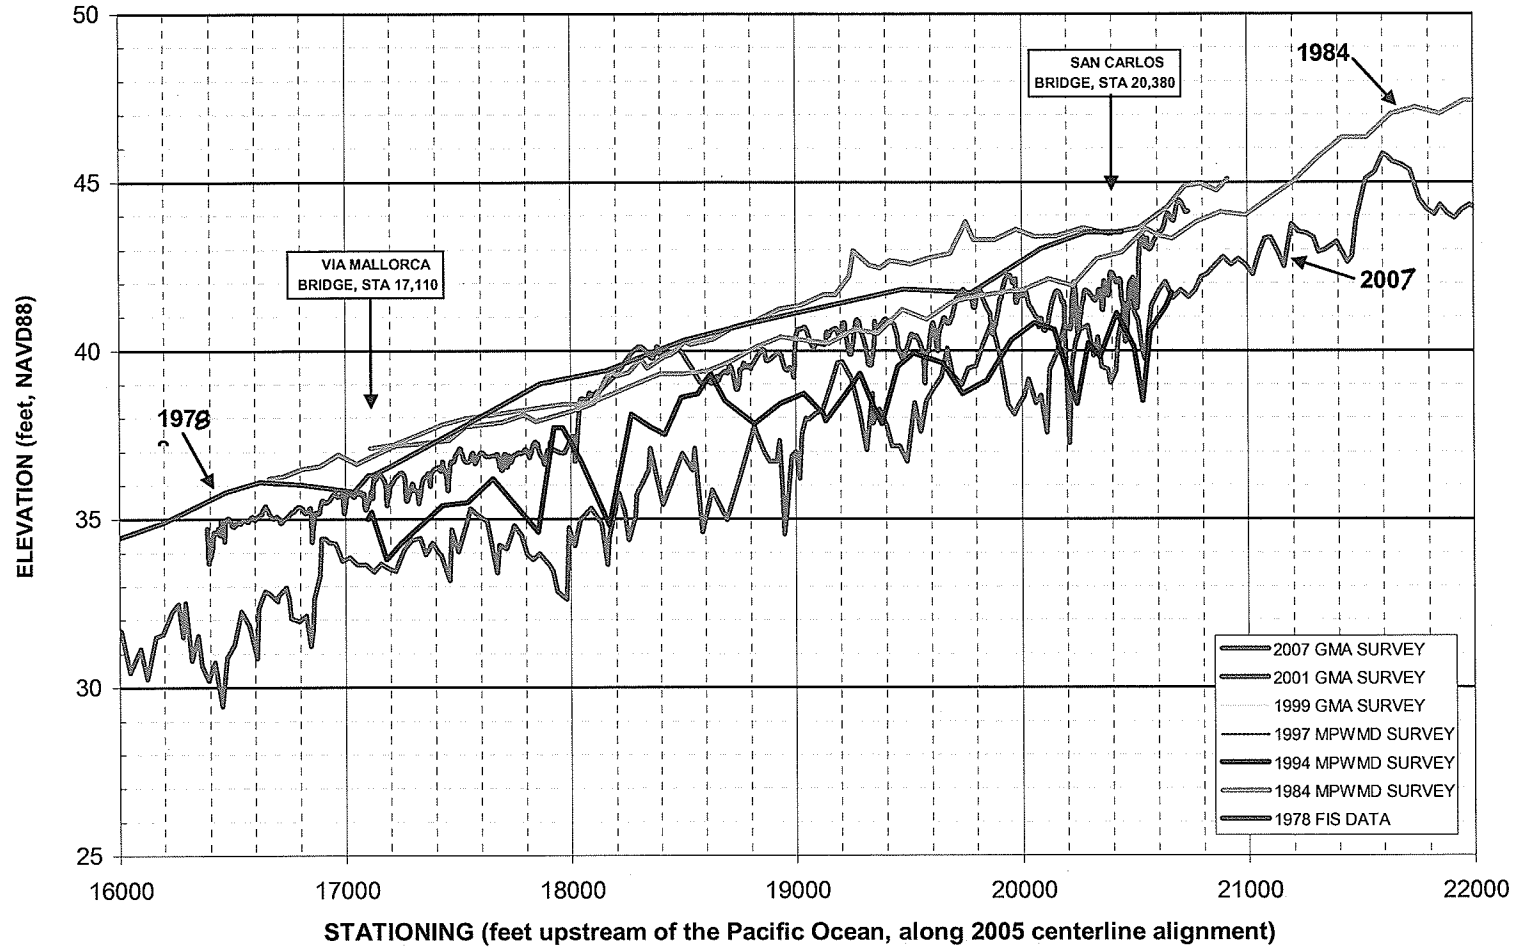
Figure X-2

CARMEL RIVER

Thalweg Profiles, Vicinity of Via Mallorca to San Carlos Road, 1978-2007

Staff has observed that many pool areas in the lower 15 miles of the river have been scoured out and appear to be much deeper than at any time since the Mitigation Program went into effect in 1990. This condition may be due both to a lack of sediment from the upper watershed and the stabilization of streambanks in the lower river. With the banks relatively stable and little or no sediment from upstream, the streampower (i.e., the energy available to move sediment) of the lower river is directed into the channel bed. This incision into floodplain deposits is referred to technically as channel degradation. Thus, pools become deeper and when combined with scour along the outside of streambanks this creates “cut” banks. Although this leads to a more complex and dynamic channel, which is desirable condition, continued degradation can result in bank collapses and trigger an episode of erosion along the river.
