Figure II-3  
Carmel River Basin Principal Streamflow Gaging Stations

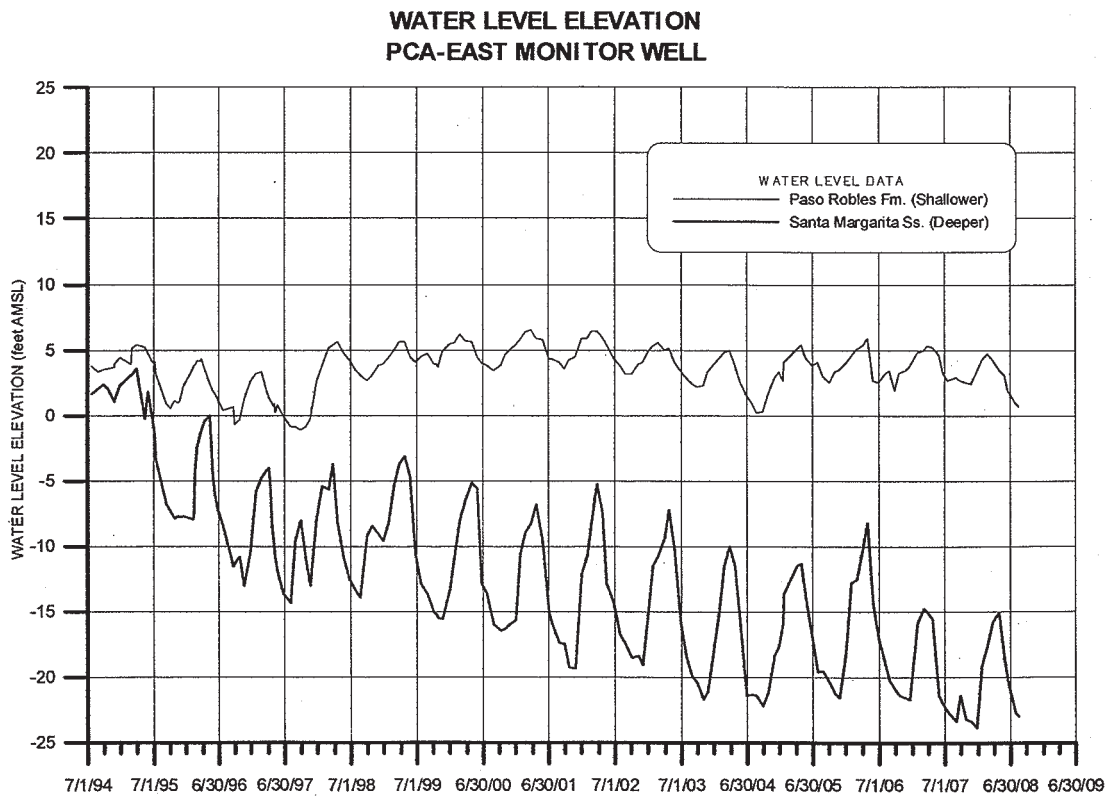
**Figure II-8**  
**Seaside Basin Groundwater Monitoring Wells**  
MONTEREY PENINSULA WATER MANAGEMENT DISTRICT

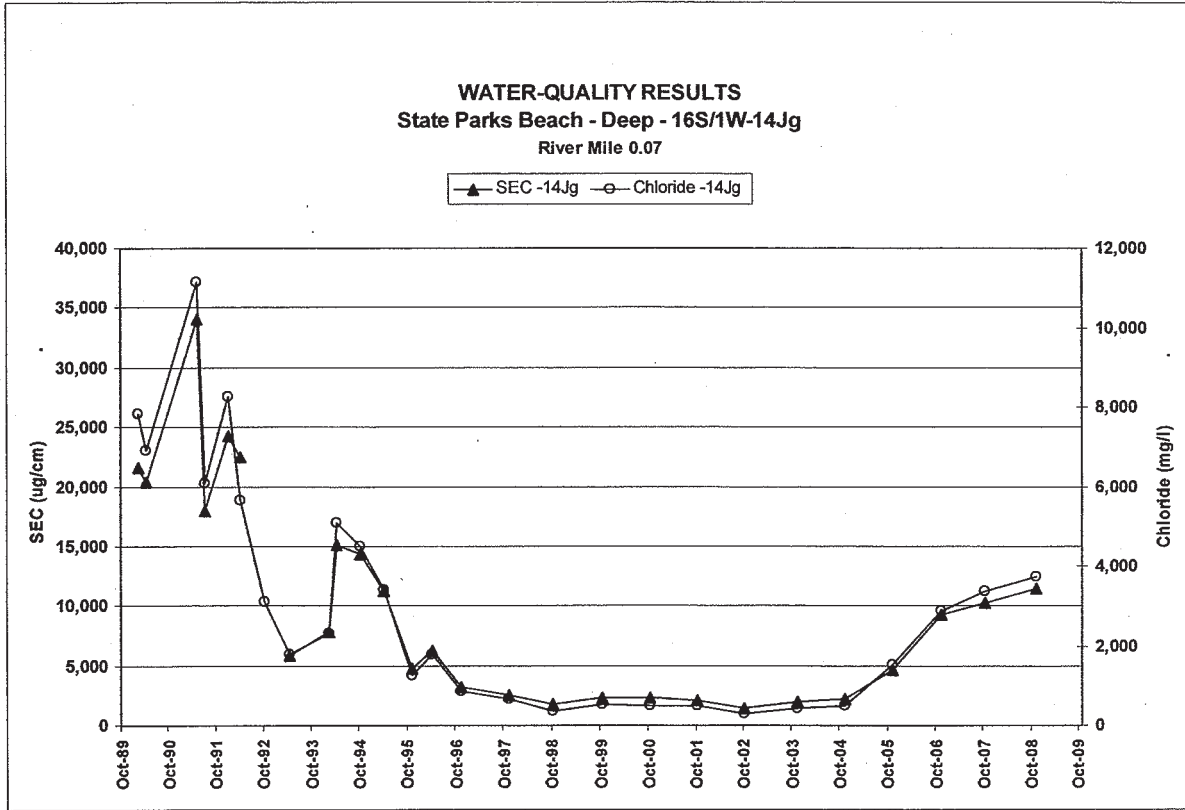
Figure II-9a: Water Quality 0.07 Miles from Coast in Carmel Valley

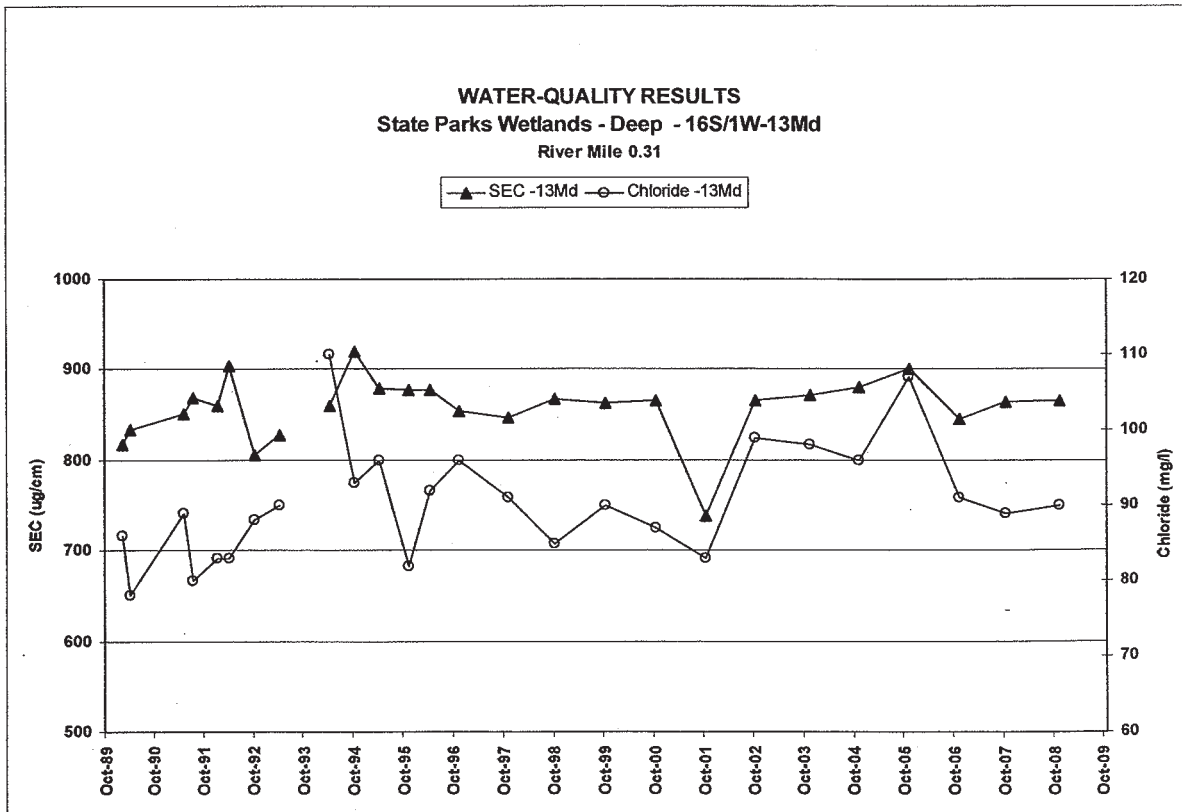
Figure II-9b: Water Quality 0.3 Miles from Coast in Carmel Valley

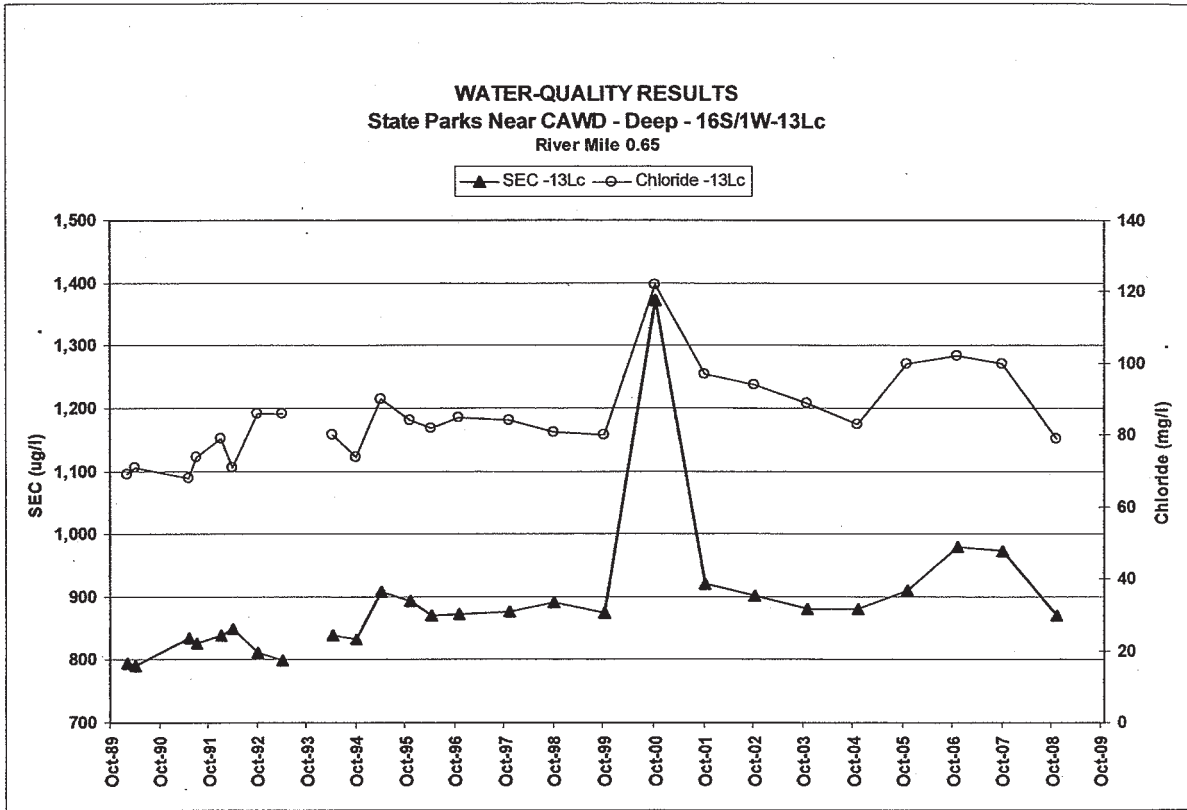
**Figure II-9c: Water Quality 0.65 Miles from Coast in Carmel Valley**

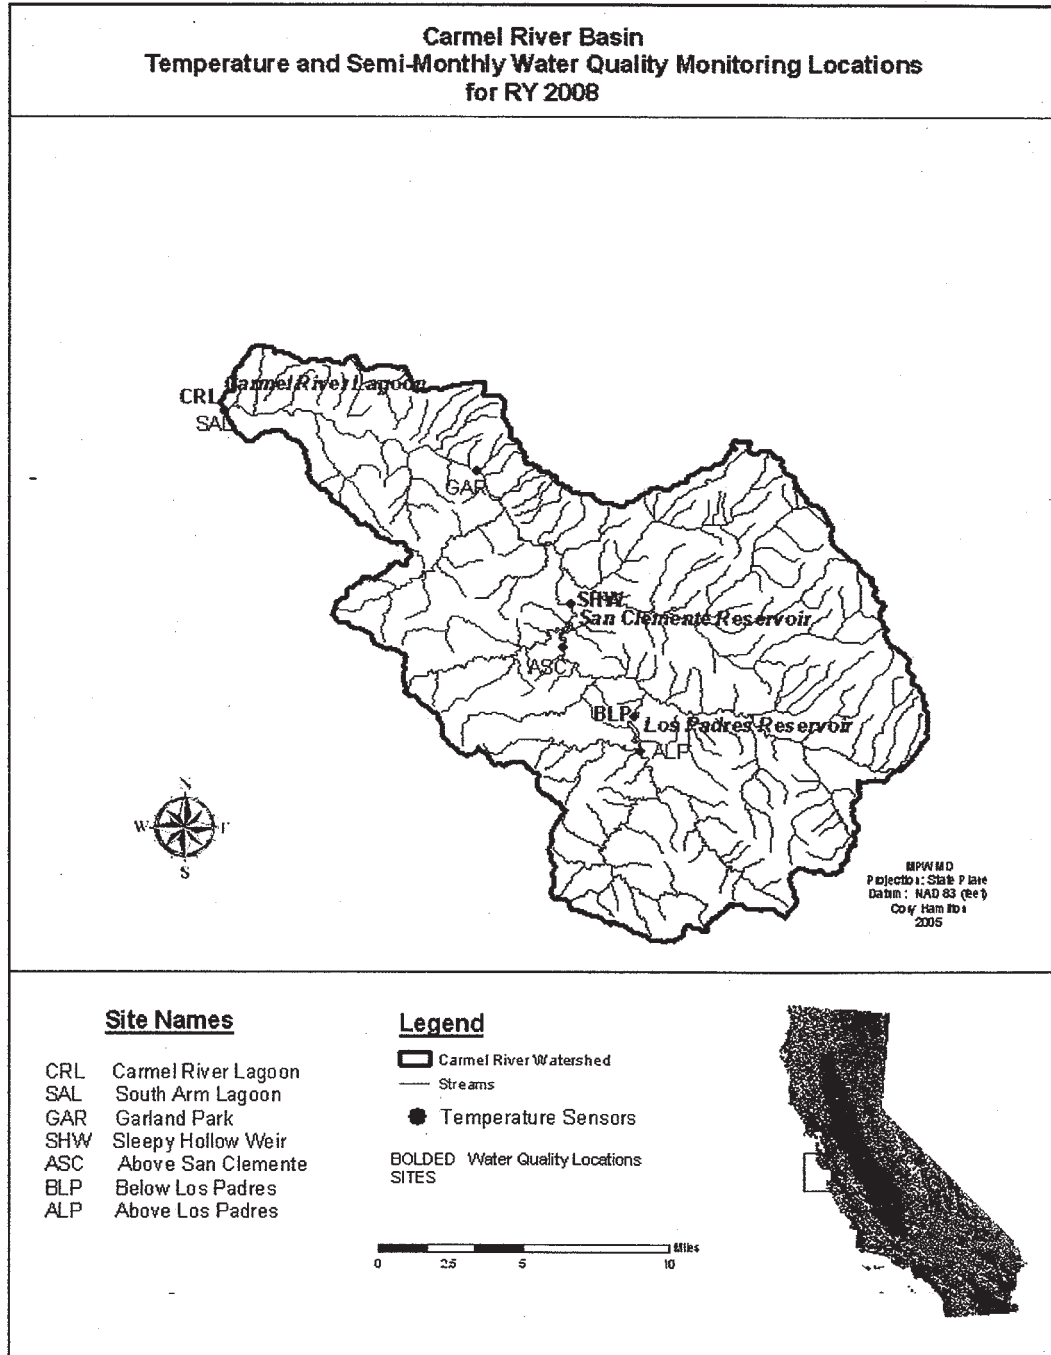
**Figure II-10**  
**Temperature and Semi-Monthly Water Quality Monitoring Locations Within the Carmel River Basin During RY 2008**
