**Figure IX-4**  
**Daily Count of Adult Steelhead Passing the San Clemente Dam Fish Ladder**  
**Compared to Daily Flow Downstream of the Ladder During the 2005 – 2006 Migration Season**

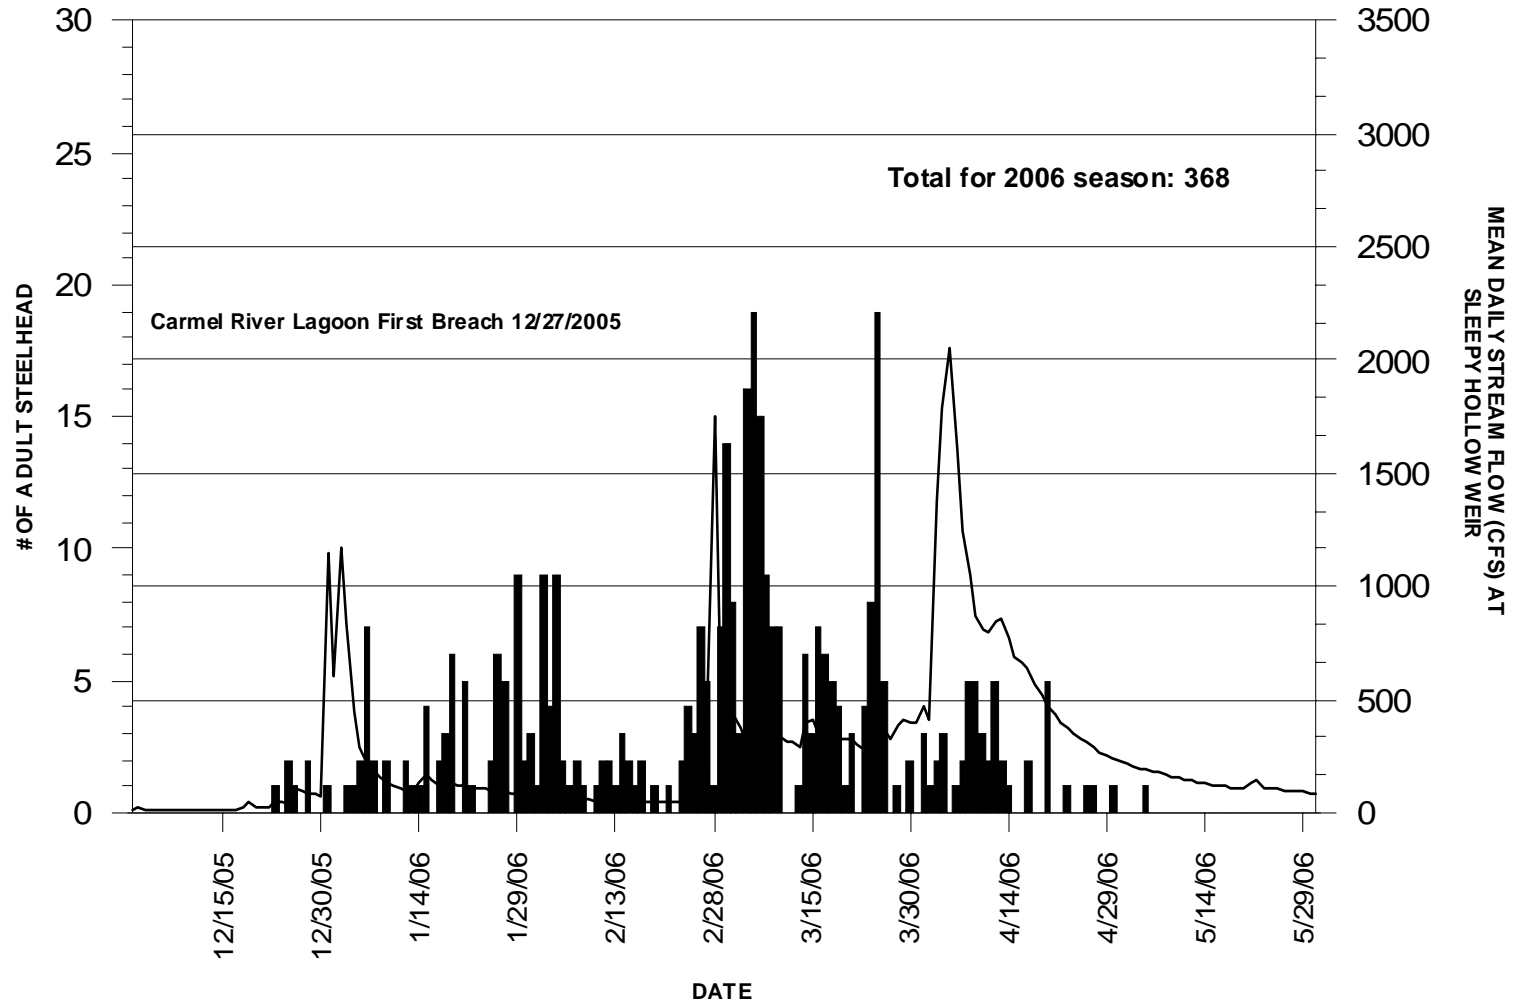
\*\* Streamflow measured at MPWMD gaging station at Sleepy Hollow Weir or San Clemente Spillway
