Figure IX-4

Adult Steelhead counts at the San Clemente Fish Ladder during RY 2008

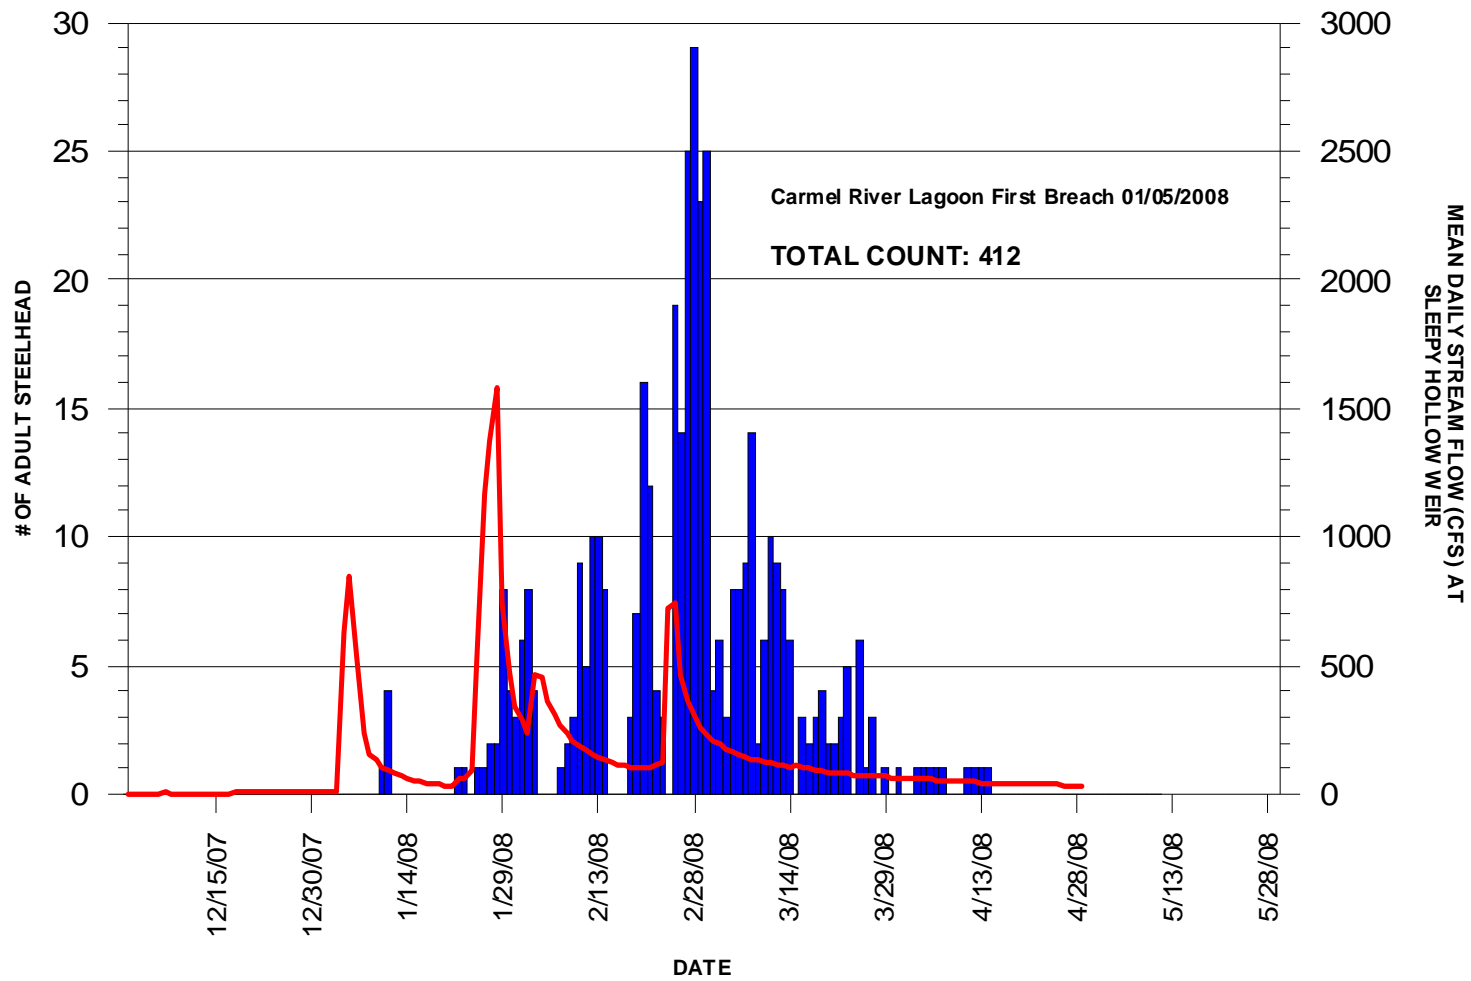
** Streamflow measured at MPWMD gaging station at Sleepy Hollow Weir or San Clemente Spillway
